# Operating Experience Weekly Summary 97-02

*January 3 through January 9, 1997*

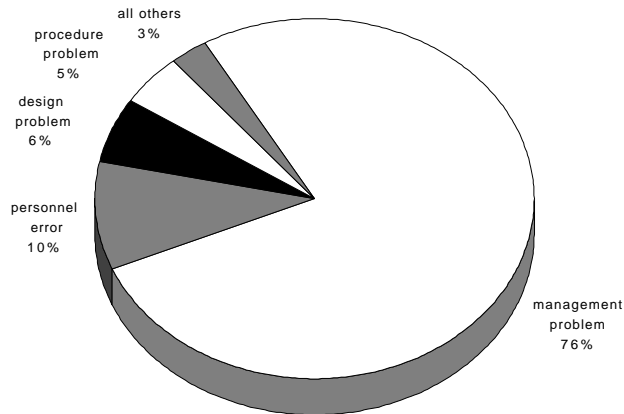
**Figure 1-1. Distribution of Root Causes for Work Planning Issues<sup>1</sup>**

Management problems contributed to 76 percent of root causes for work planning deficiencies. A breakdown, showing the percentage of the causal codes is shown in Table 1-1.

These events underscore the importance of pre-job briefings and clear work control procedures for implementing maintenance work. Numerous sections in DOE 4330.4A, *Maintenance Management Program*, provide guidance on the elements necessary for effective maintenance programs at DOE facilities. DOE/EH-0256T, *Radiological Control Manual*, provides guidance on planning and performing radiological work. The radiological work permit is an administrative mechanism used to establish radiological controls for work activities. The responsibility for ensuring adequate planning and control of work activities resides with line management. The lead work group responsible for the planned activity or for the area should initiate preparation of the permit. Managers should ensure that work control processes are followed and radiological protection practices are enforced. DOE-STD-1050-93, *Guideline To Good Practices For Planning, Scheduling and Coordination of Maintenance at DOE Nuclear Facilities*, section 3.1.1.3, provides the key elements of an effective planning program. Included is guidance on consistency in planning between disciplines to avoid confusion and frustration of work groups. The standard also discusses the need for thorough reviews of work packages by experienced individuals to eliminate errors. Planning managers at DOE facilities should review their programs to ensure consistency with the standard.

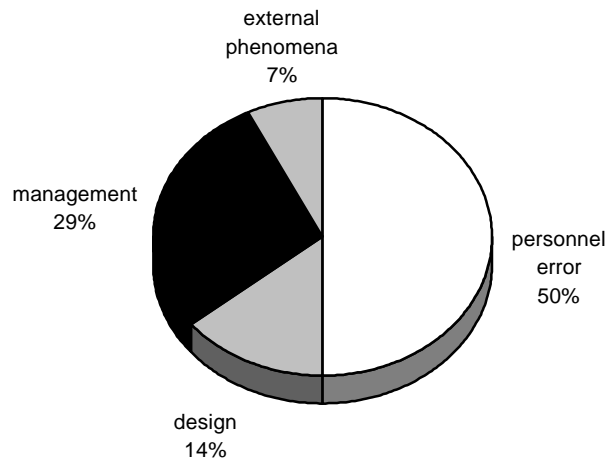
**Figure 4-1. Distribution of Root Causes for Contacting Overhead Lines<sup>3</sup>**

Personnel errors accounted for 50 percent of the events, and management problems contributed to 29 percent. A breakdown, showing the percentage of these cause codes, is shown in Table 4-1.

These events demonstrate the importance of exercising extreme caution when operating cranes, front-end loaders, forklifts, and other vehicles in the vicinity of guy wires, power lines, and switchyards. Pre-job briefings, facility procedures, and training programs should emphasize the dangers associated with these types of operations. Many events have occurred while personnel were backing up motive units, indicating that operators of equipment must be aware of hazards in all directions, including above them. DOE 4330.4B, *Maintenance Management Program*, section 8.3.1, provides guidelines on work control systems and procedures. The Order requires control procedures to help personnel understand the requirements for working safely. OSHA regulation 29 CFR 1926.550(a)(15)(iv), "Cranes and Derricks," states that a person shall be designated to observe clearance of the equipment and give timely warning for all operations where it is difficult for the operator to maintain the desired clearance by visual means. Section 1926.600(a)(6), "Equipment," states: "all equipment covered by this subpart shall comply with the requirements of 1926.550(a)(15) when working or being moved in the vicinity of power lines or energized transmitters." DOE facility managers should ensure that personnel understand the basics of work control practices, work planning, and safety and health hazard analysis.
